TECHNICAL REPORT M10

**SEDIMENTATION AND NAVIGATION STUDY OF THE
MISSOURI RIVER,
COPELAND BEND
MILES 569 TO 564.5**

HYDRAULIC MICRO MODEL INVESTIGATION

Final Report - September, 1999

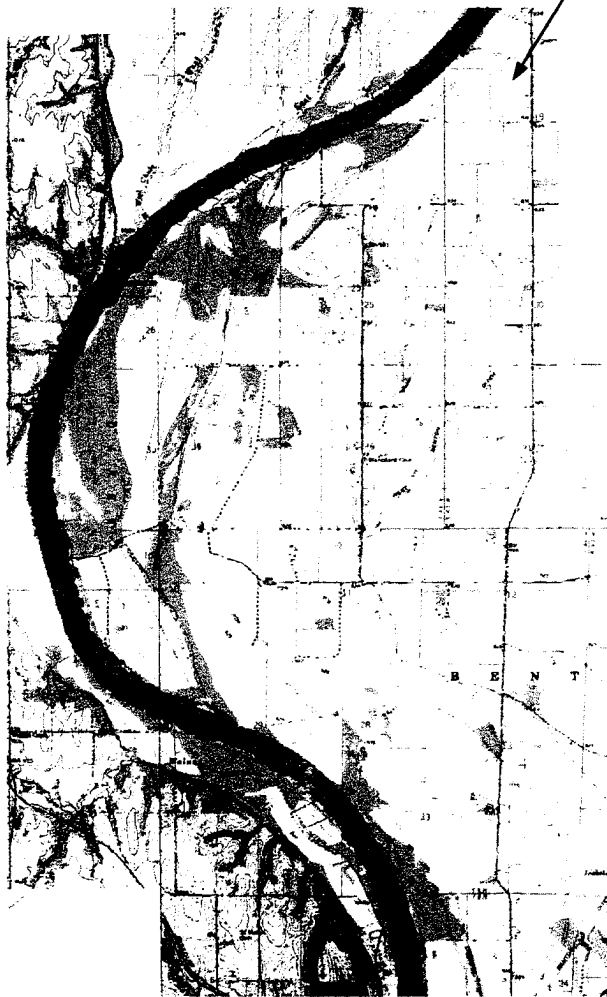
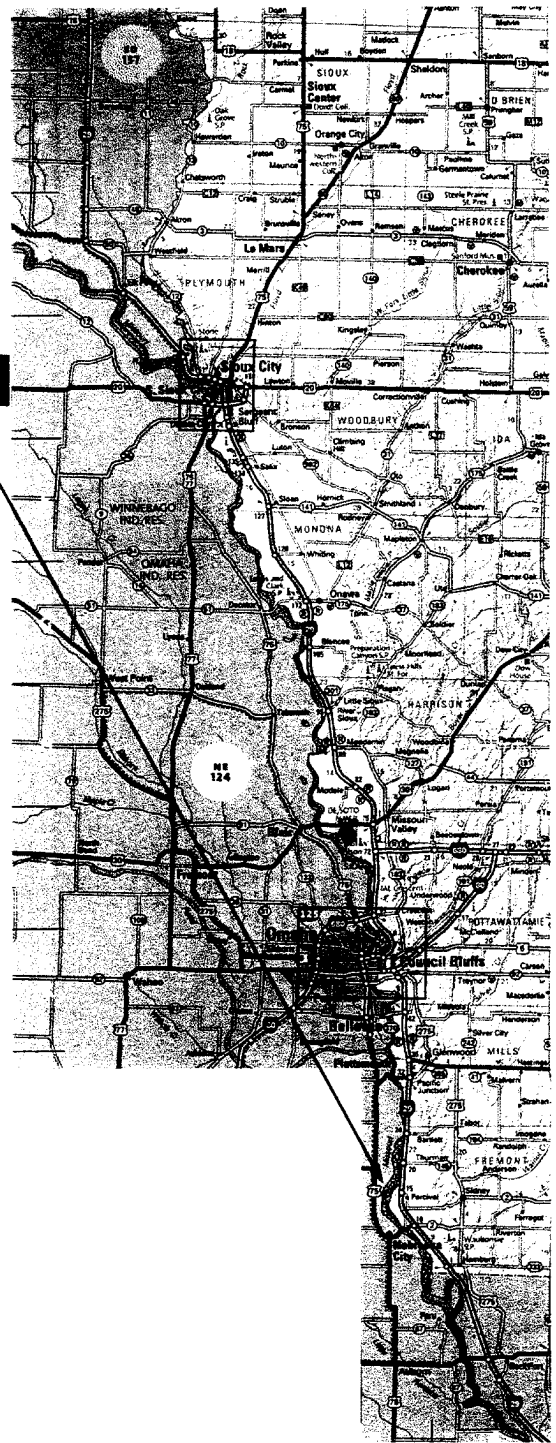
1

Study Reach

Plates 1, 2, and 3 are maps depicting the characteristics, configuration, and nomenclature of the Missouri River through this particular study reach. A combination of wooden pile and rock dike structures (Plate 2) have been constructed and maintained by the Omaha District to achieve a self maintaining navigation channel and stable channel alignment along the left descending bankline.

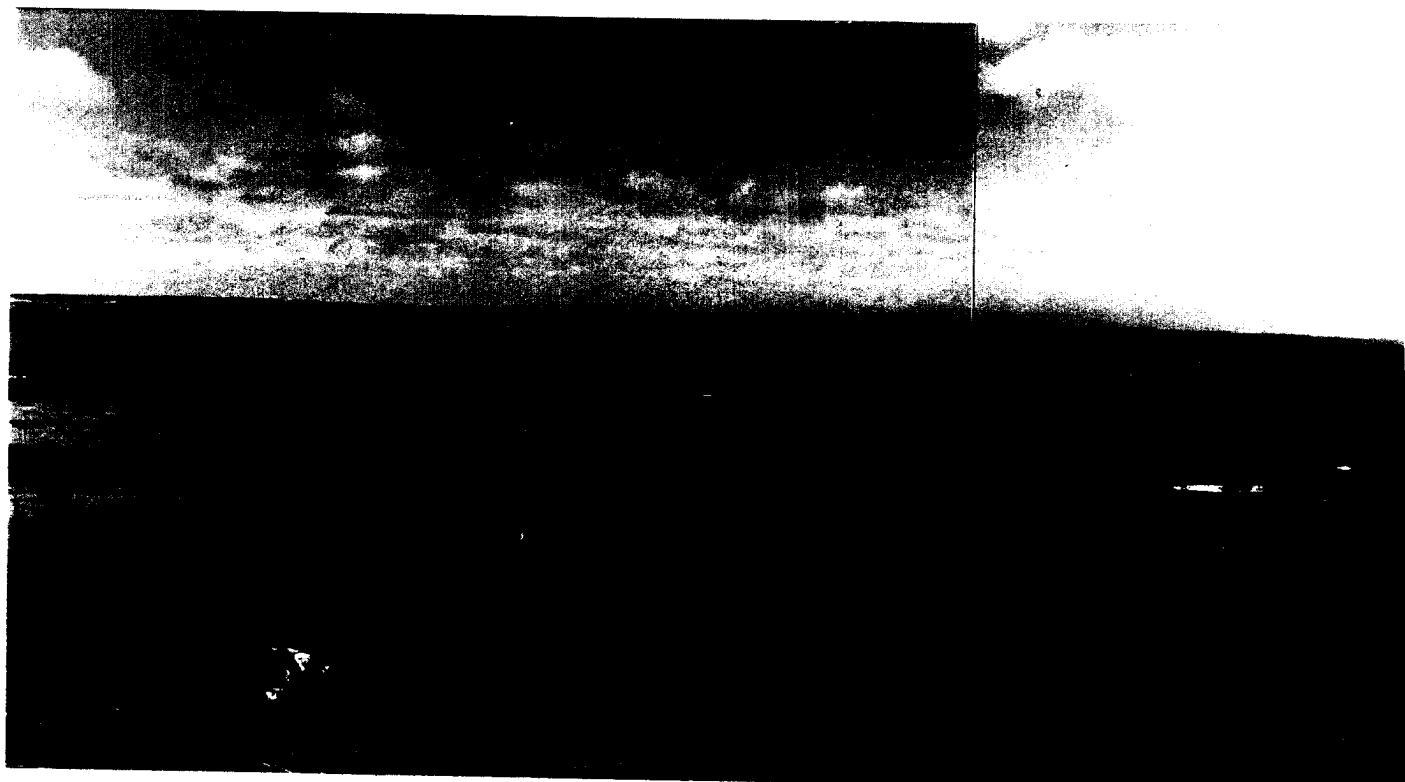
**Copeland Bend, Looking Across the Floodplain Toward
the Left Descending Bank, From Nebraska Bluff**

In December of 1998, river engineers from the St. Louis District made a field investigation of the study reach. Plates 4 through 10 are photographs taken during this inspection. The following observations were noted:

- All of the dikes were angled slightly downstream, which has caused small bankline roundouts to occur below each structure. The bankline roundouts appeared to be stable, however, and the integrity of the dikes was not in jeopardy.
- An unusual amount of mature trees were destroyed near and along the left descending bankline due to beaver impacts. This could cause future lateral erosion of the existing bankline.

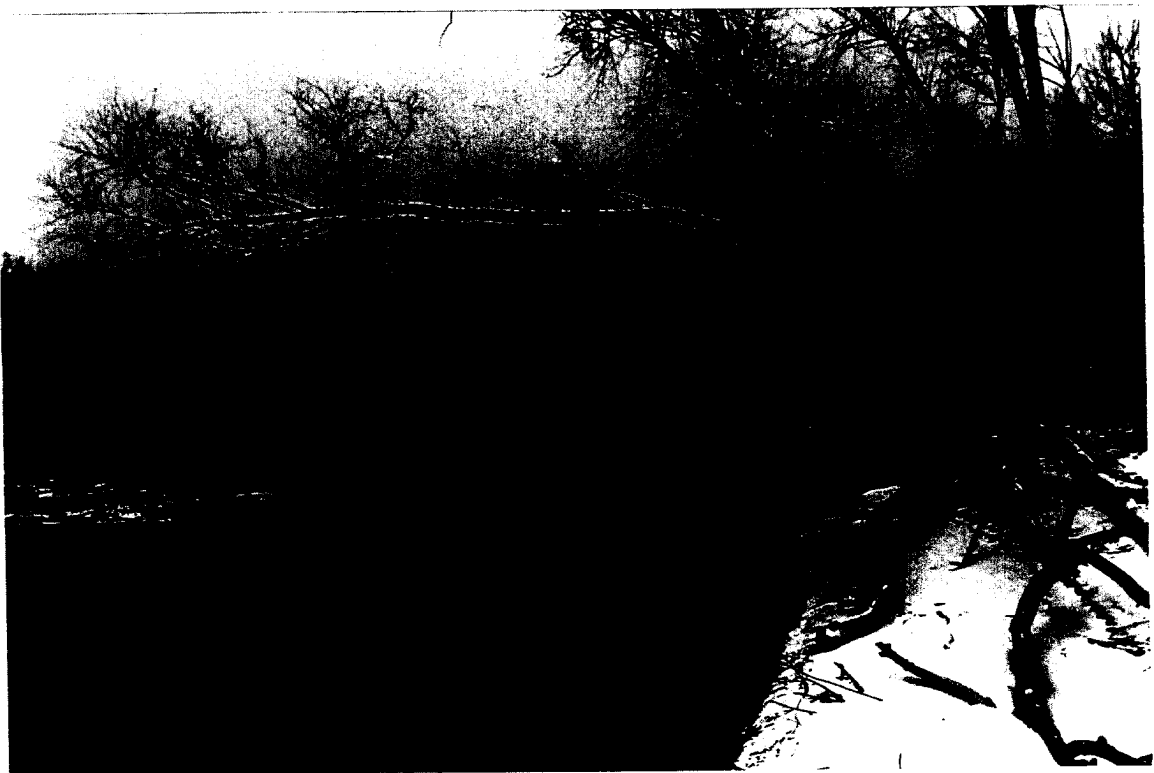
5

Copeland Bend, Looking Upstream at Dike 612.5

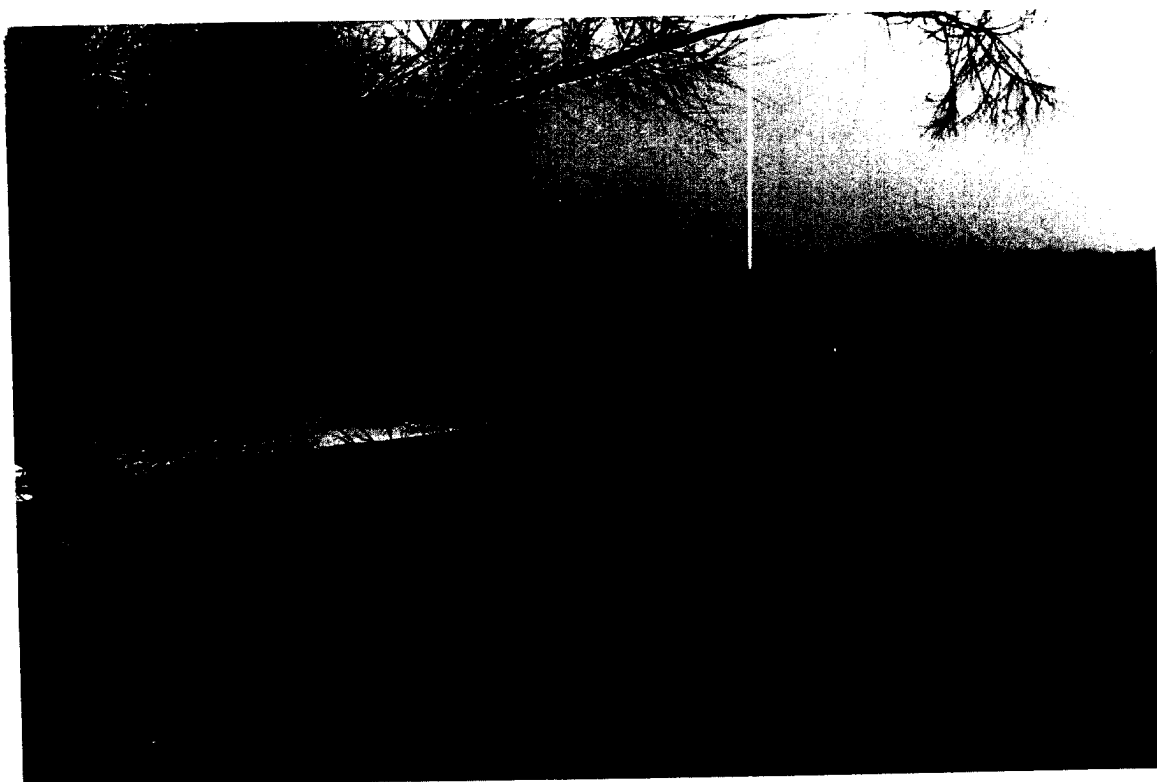
6

Copeland Bend, Looking Downstream At Dike 612.5

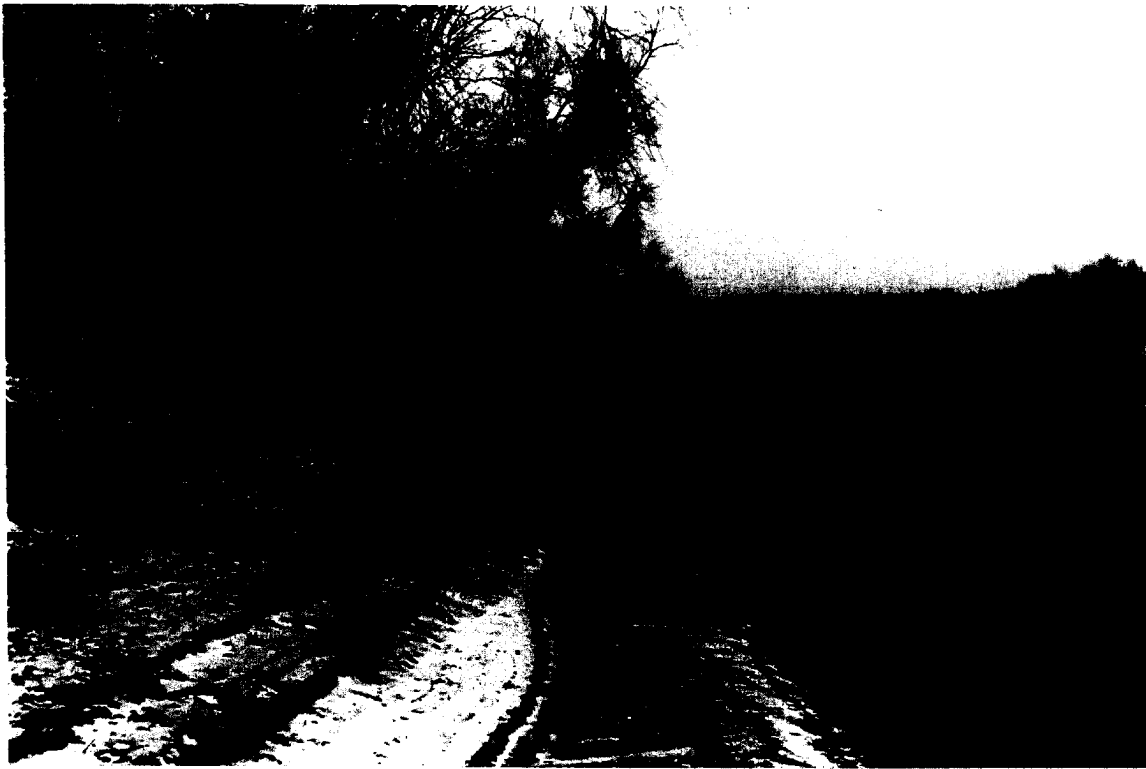
7

Copeland Bend, Looking Downstream From Dike 612.5

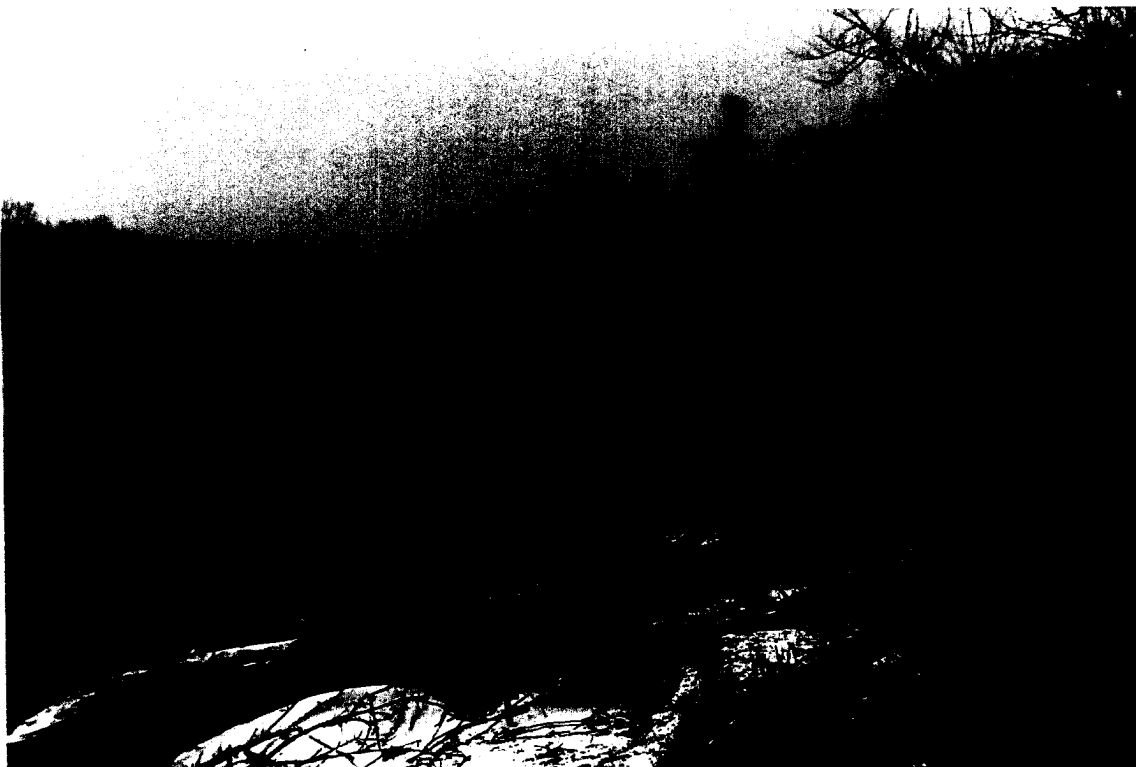
8

Copeland Bend, Looking Upstream at Dike 612.6

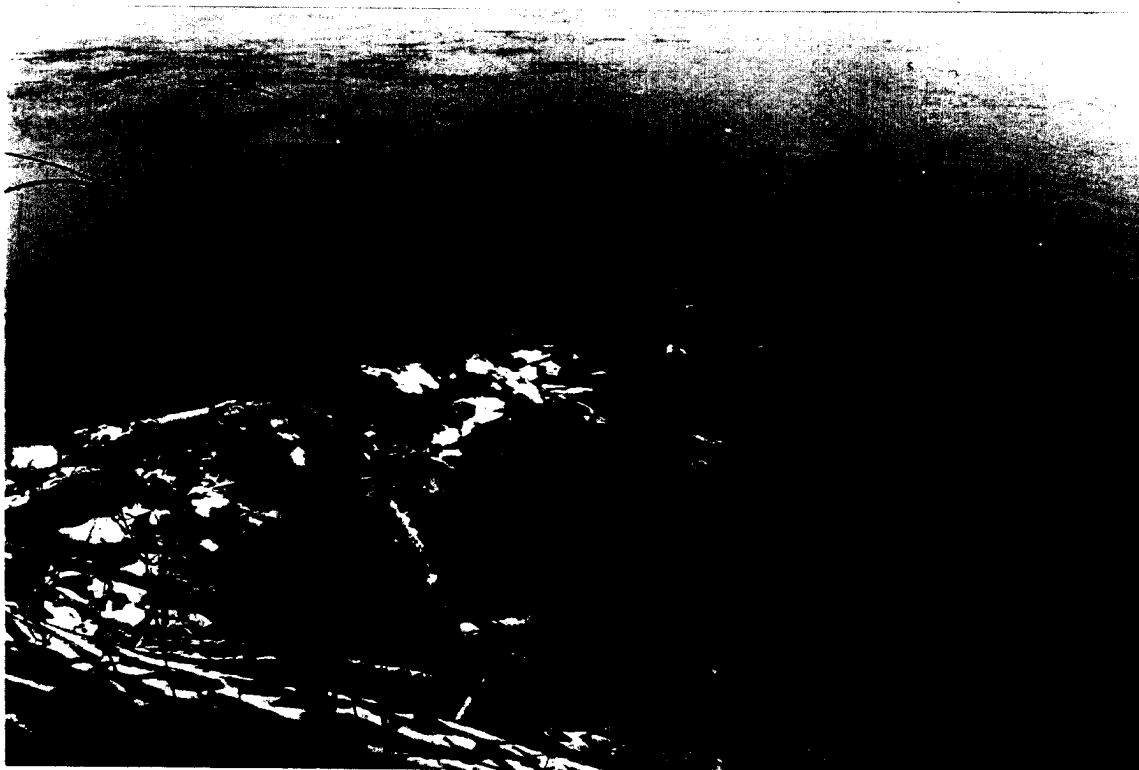
9

Copeland Bend, Looking Directly at Dike 612.6

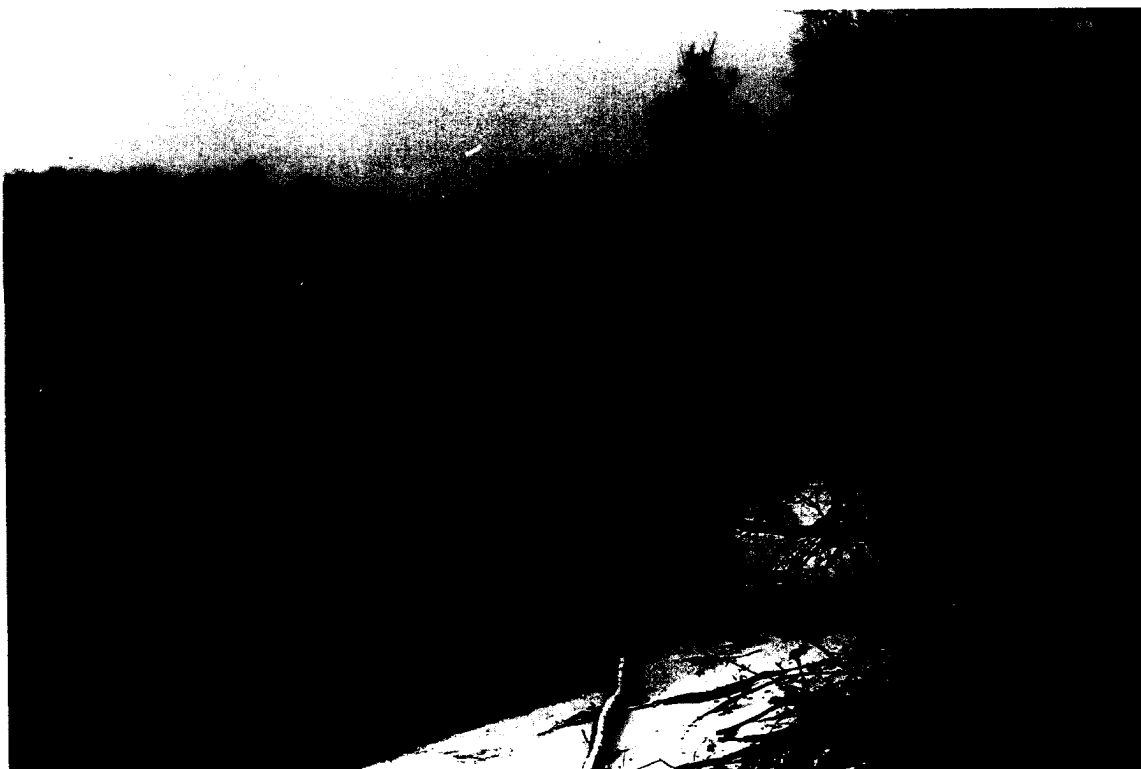
PLATE NO. 10

Copeland Bend, Looking Upstream at Dike 612.7

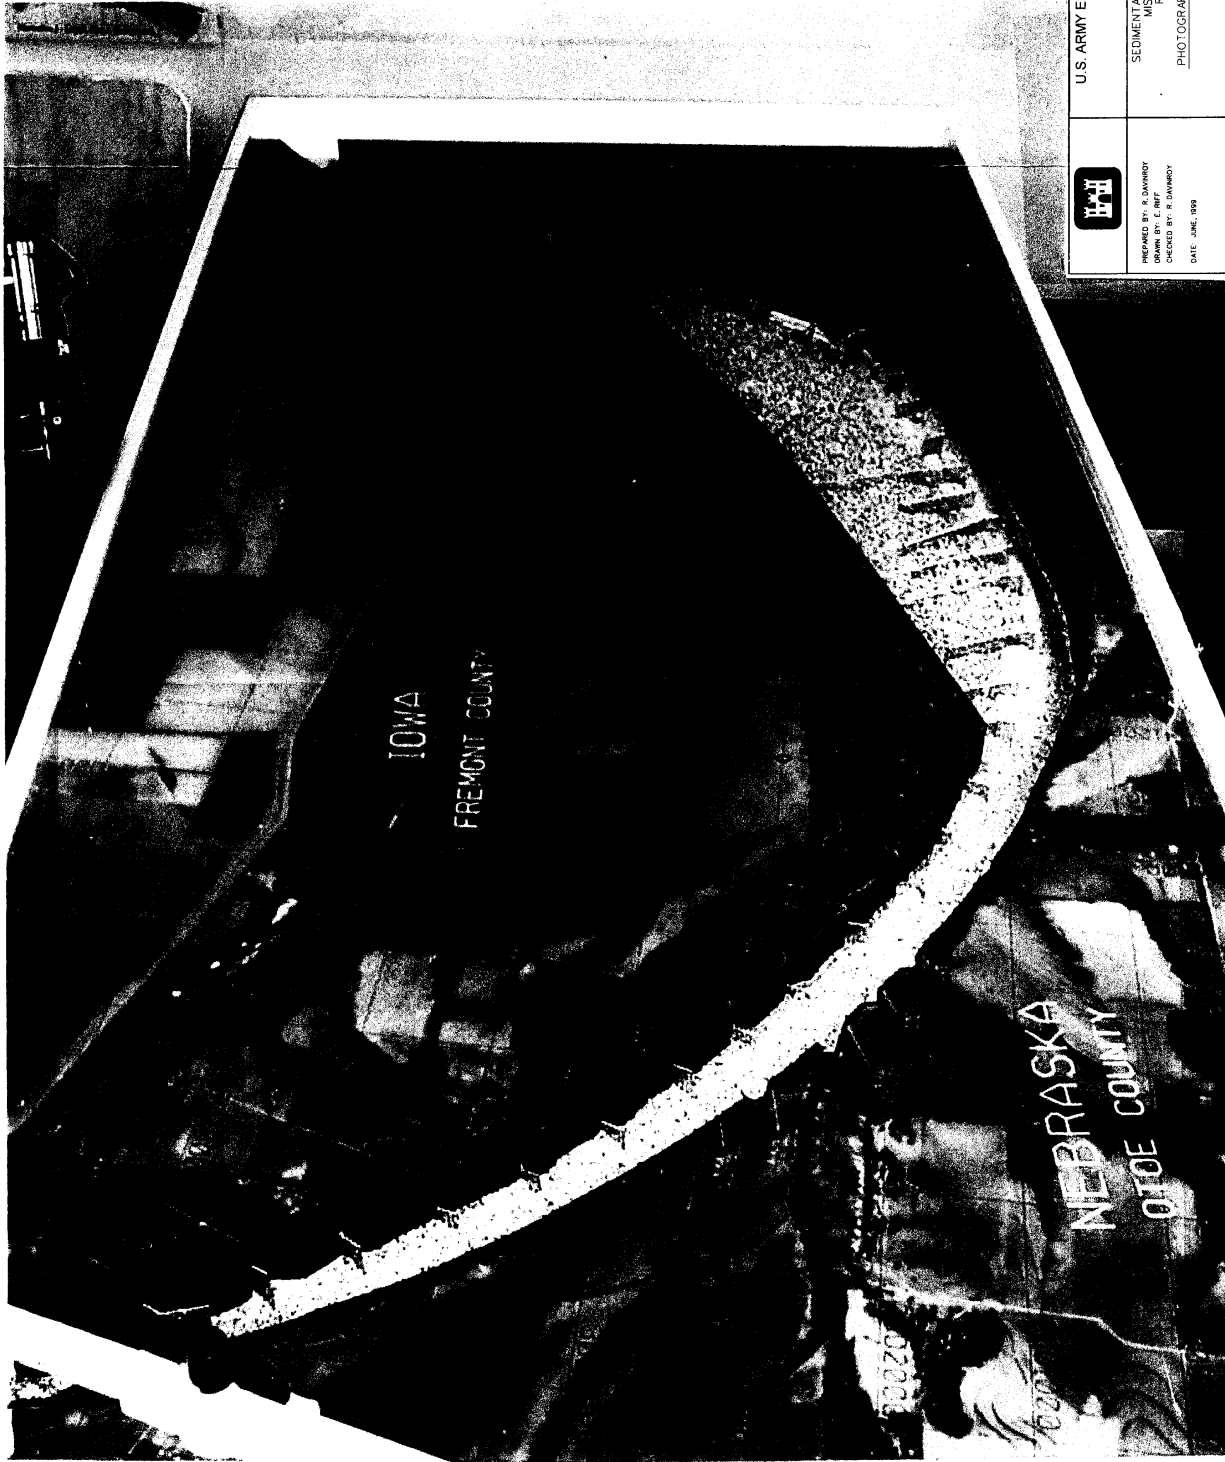
PLATE NO. 11

Plate 11 is a photograph of the Copeland Bend hydraulic micro model used in this study. The scales were 1 inch = 300 feet, or 1:3600 horizontal, 1 inch = 20 feet, or 1:240 vertical, for a 15 to 1 distortion ratio. This distortion supplied the necessary forces required for the simulation of sediment transport conditions similar to those of the prototype. Both the bed material and the erodible floodplain section were composed of granular plastic urea, Type II, with a specific gravity of 1.23.

The model was constructed according to 1996 aerial photographs of the Missouri River. Flow was controlled via an electronic/computer program interfaced with a centrifugal pump and a mechanical process control valve. Stages and dike structures were recorded with a mechanical three-dimensional digitizer.

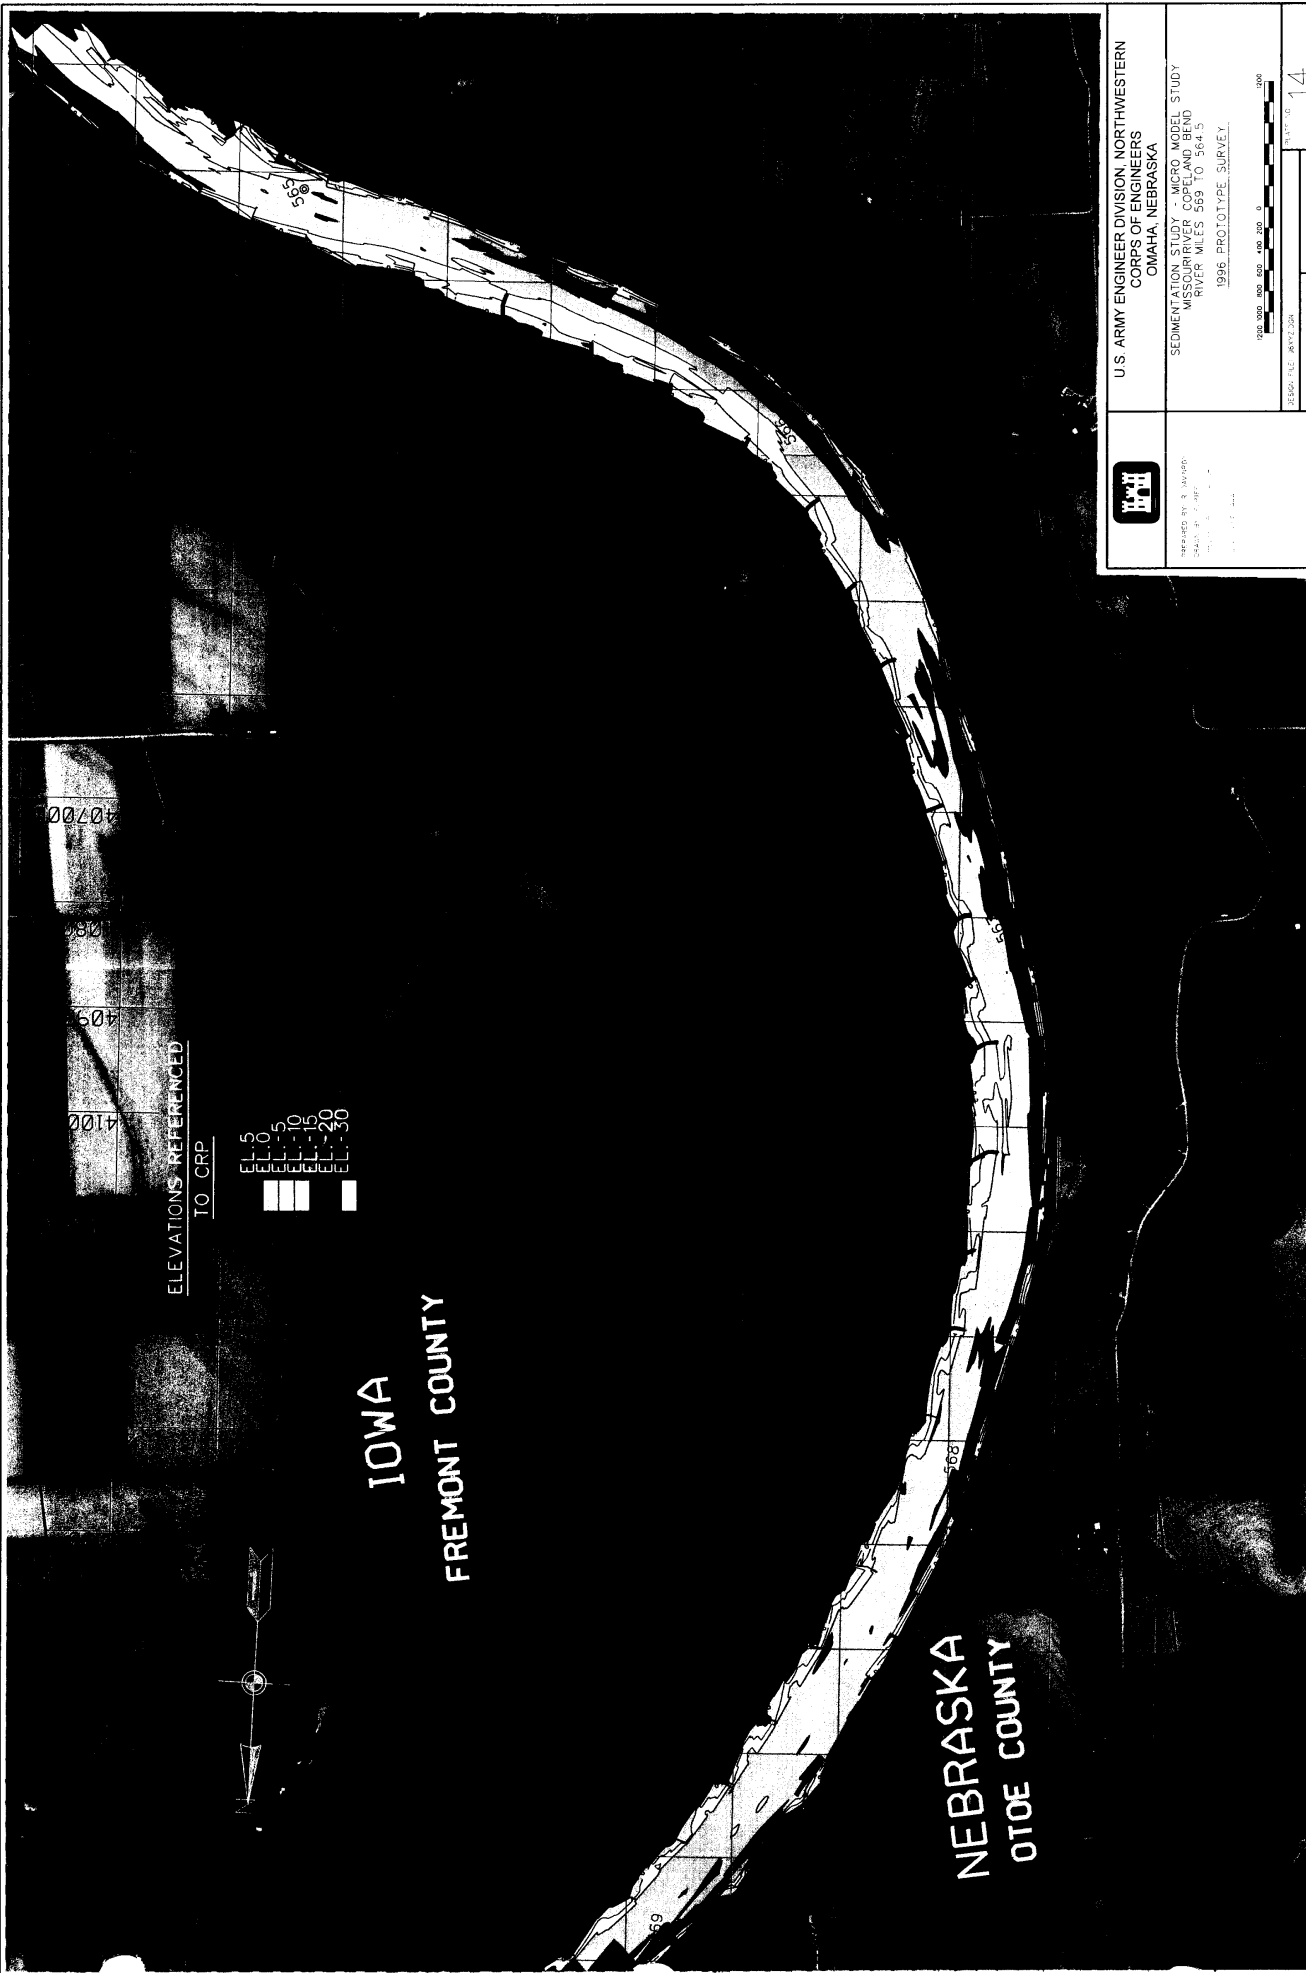
PLATE NO.
13

ELEVATIONS REFERENCED
TO CRP

The 1996 and 1991 prototype surveys were used in this study to determine the general bed distribution characteristics that have existed in the prototype over recent years (Plates 13 and 14). All depths and color contours were referenced in feet above or below the Construction Reference Plane (CRP) established on the Missouri River.

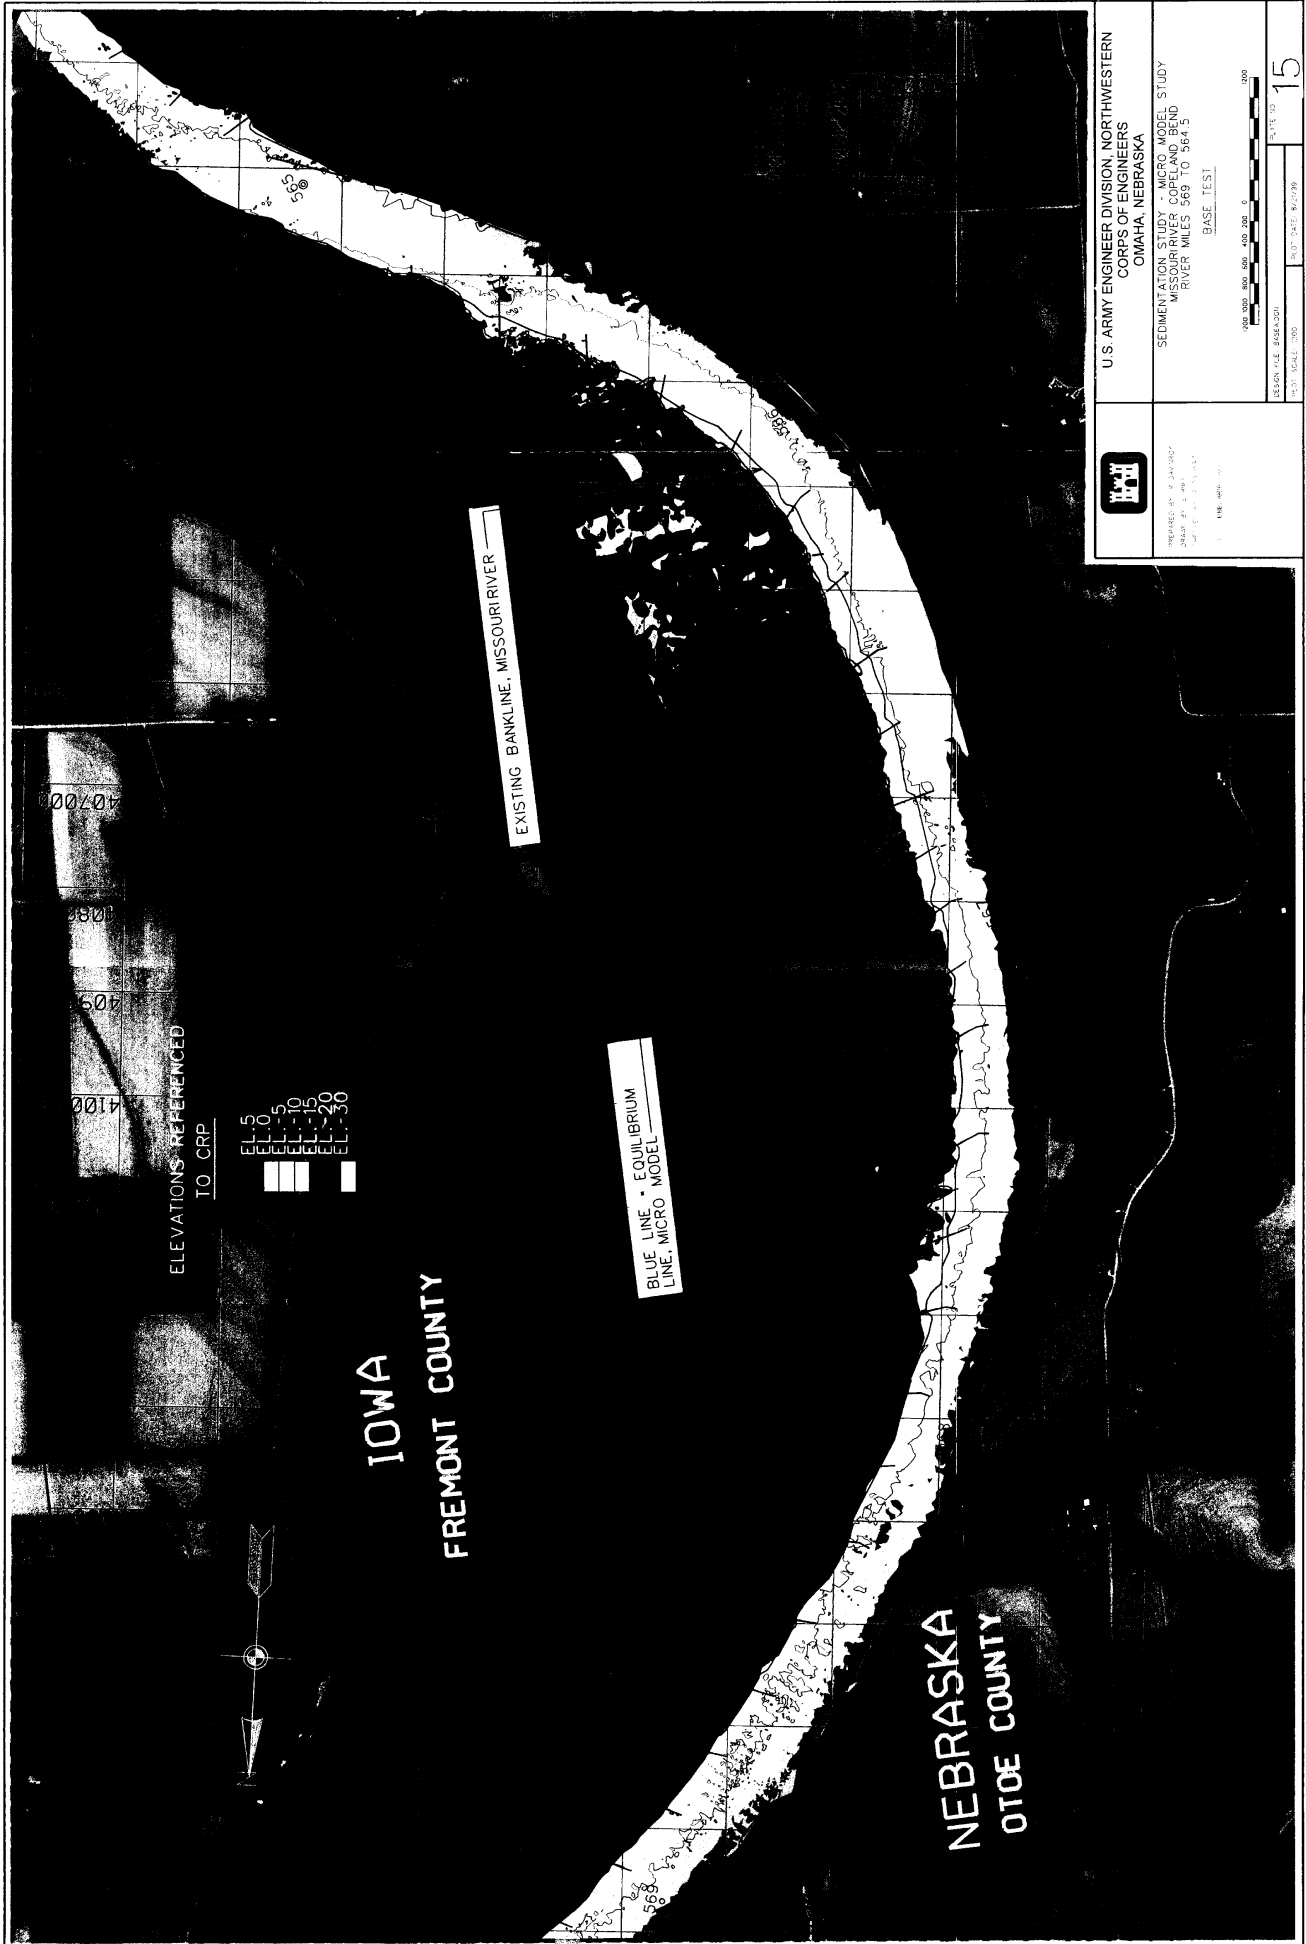
Plate 15 shows the resultant bed configuration of the micro model base test. The base test was developed from the simulation of successive design hydrographs until bed stability was reached and a similar bed response was achieved as compared with the prototype surveys. The observed trends of the model were as follows:

SEDIMENTATION STUDY - MICRO MODEL STUDY
MISSOURI RIVER, COPELAND BEND
RIVER MILES 569 TO 564.5
BASE TEST

The general bathymetric trends of the base test were very similar to those of the two observed prototype surveys of 1991 and 1996. Generally, the thalweg was located in the same positions as in the prototype. The depositional patterns

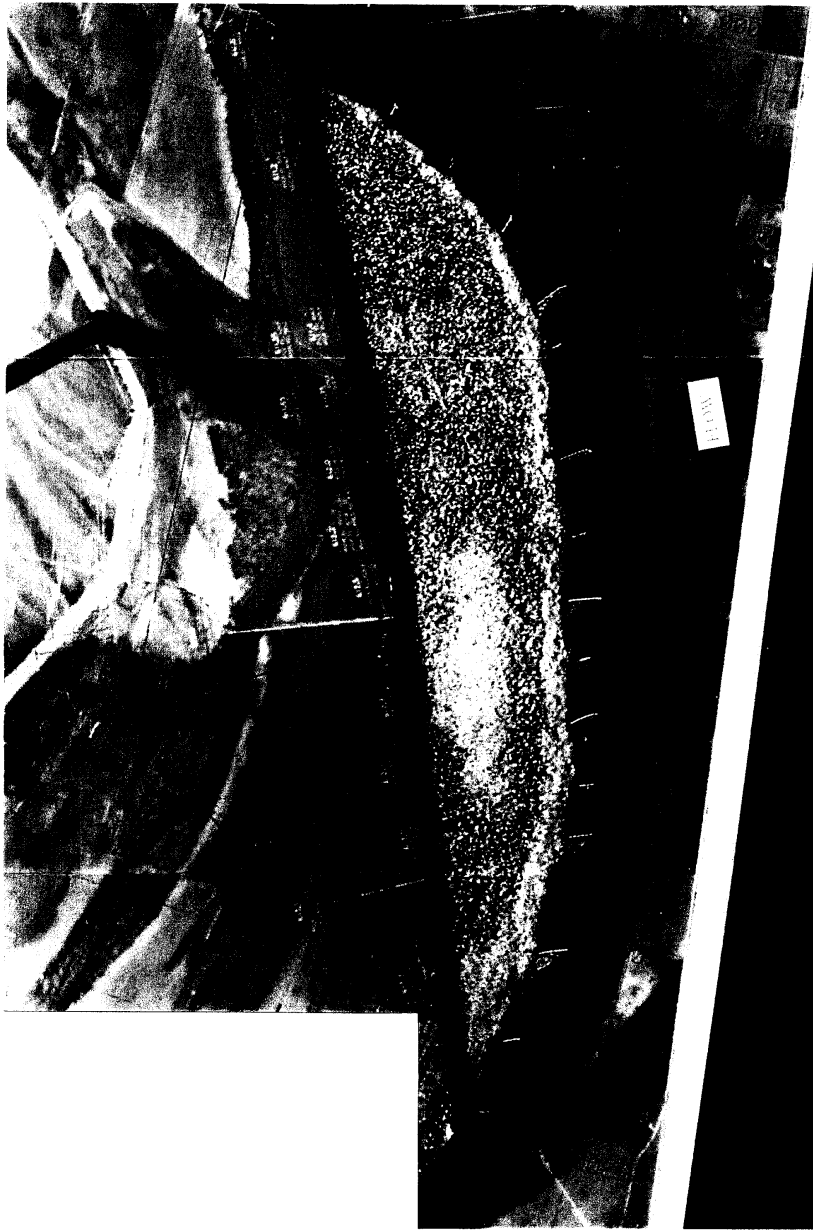
PLATE NO. 16

Plate 16 shows the flow visualization of the base test. All flow visualization photographs were captured throughout the model tests with the stage of the model at approximately + 2 CRP. Results indicated that the flow through the study reach was distributed fairly uniformly in the navigation channel, between the ends of the dikes and the right descending bankline, except at Mile 566.0, where flow was more concentrated at the apex of the bend adjacent to the point bar. The influence of the dikes in diverting flow away from the left descending bank and generating eddies was observed in the model. Flow visualization did not capture the eddies, however, the visualization did show the relative slower moving water within the dike field.

U.S. ARMY ENGINEER DIVISION, NORTHWESTERN CORPS OF ENGINEERS OMAHA, NEBRASKA
PREPARED BY: E. C. Carney CHECKED BY: D. Gordon DATE: FEBRUARY 1959	Sedimentation Study Missouri River, Copeland Bend Flow Visualization Base Test

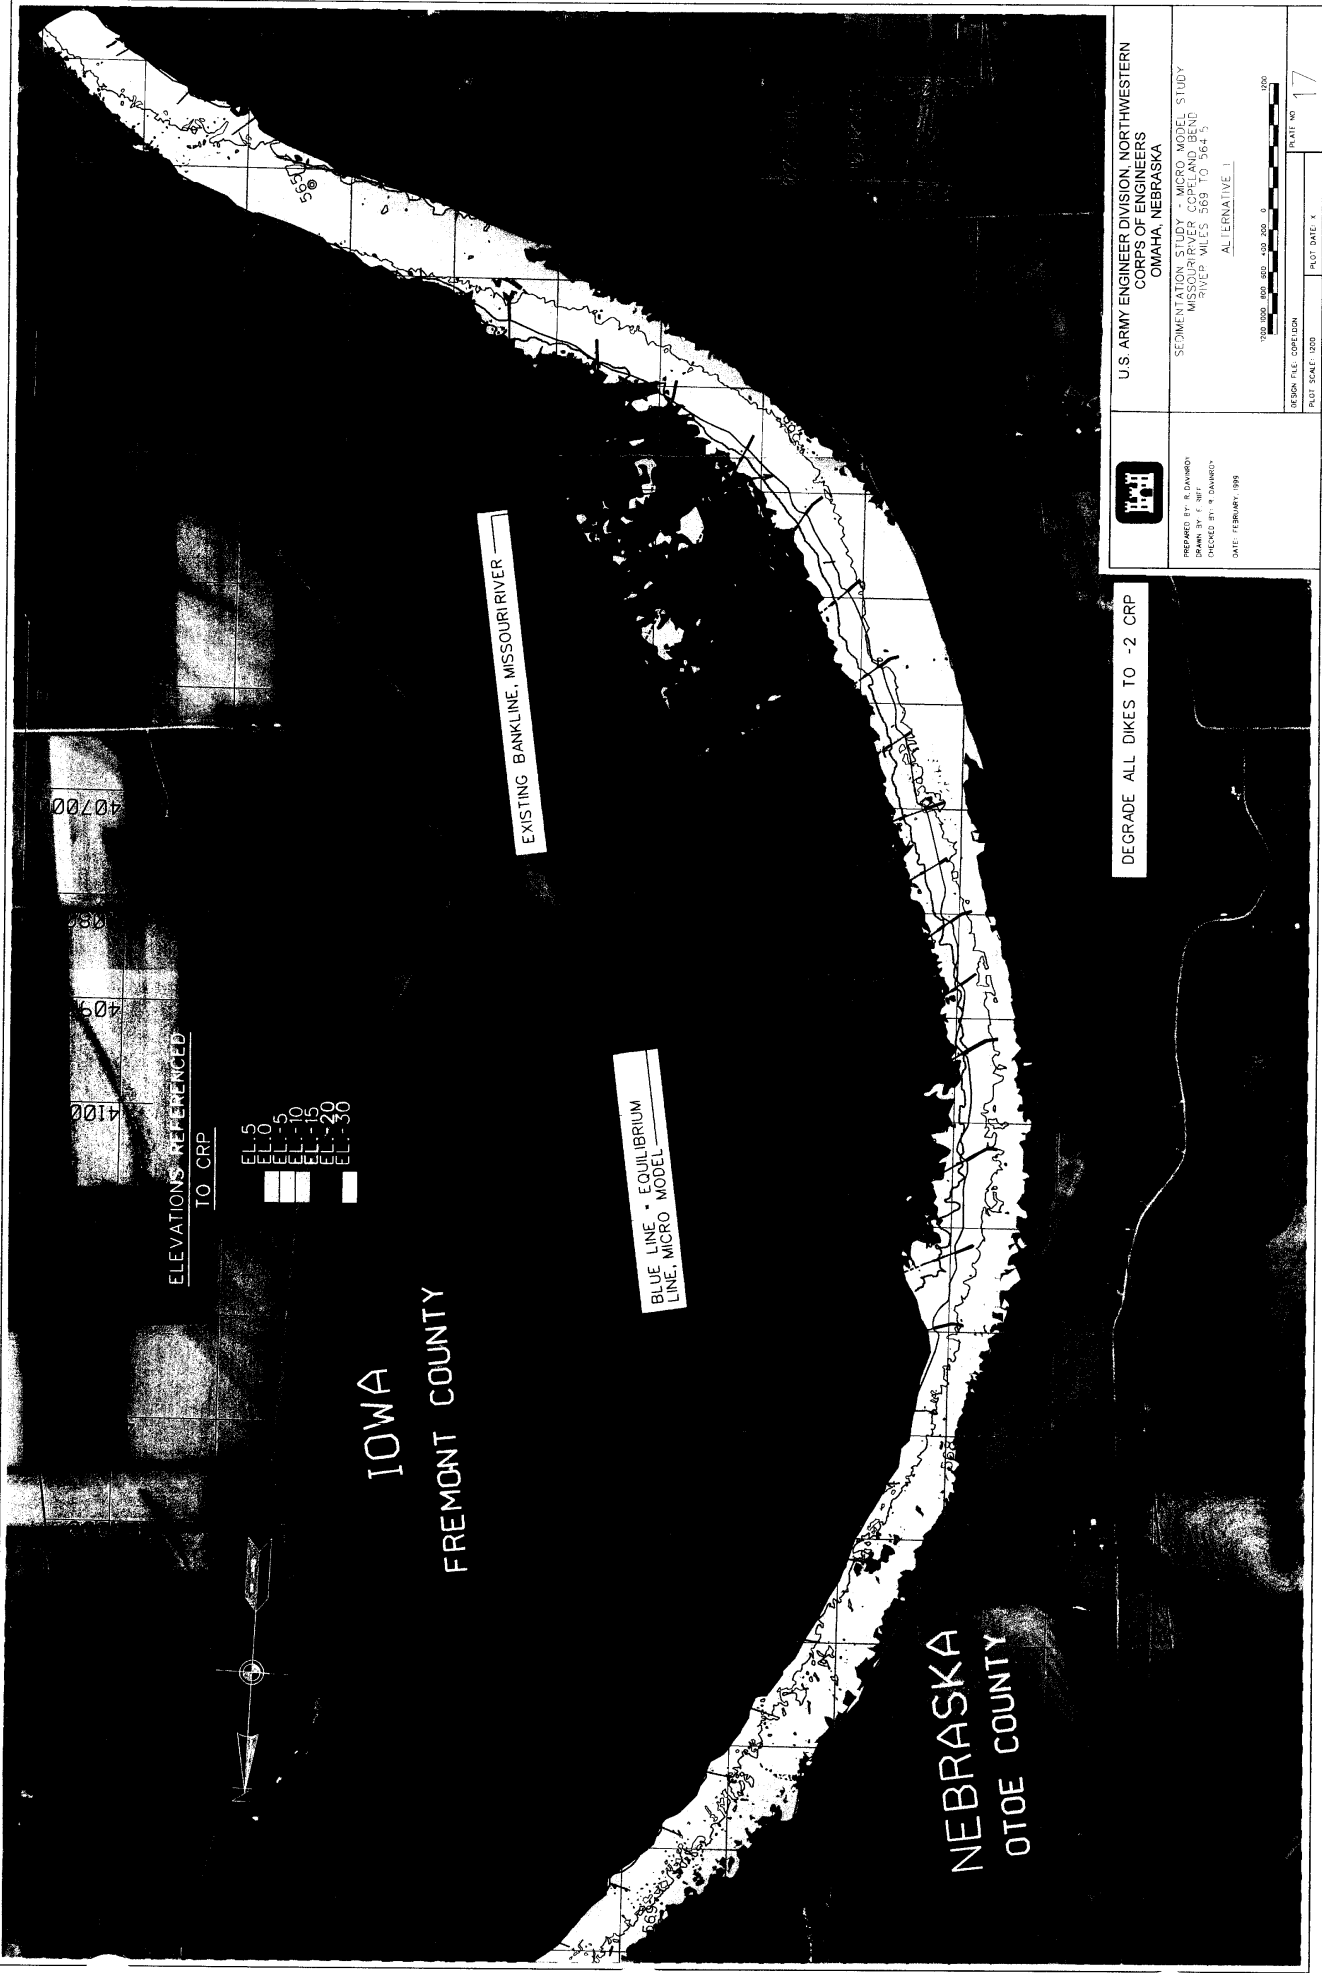
Alternative 1. Degrade All Existing Dikes To -2 CRP. Alternative 1 involved the degradation of all dikes to -2 CRP on the left descending bank, between Miles 567.8 and 565.3. Results (Plates 17, 18, 19) indicated the following trends:

DEGRADE ALL DIKES TO -2 CRP

SEDIMENTATION STUDY - MICRO MODEL STUDY
MISSOURI RIVER, COPELAND BEND
RIVER MILES 569 TO 564.5
ALTERNATIVE 1

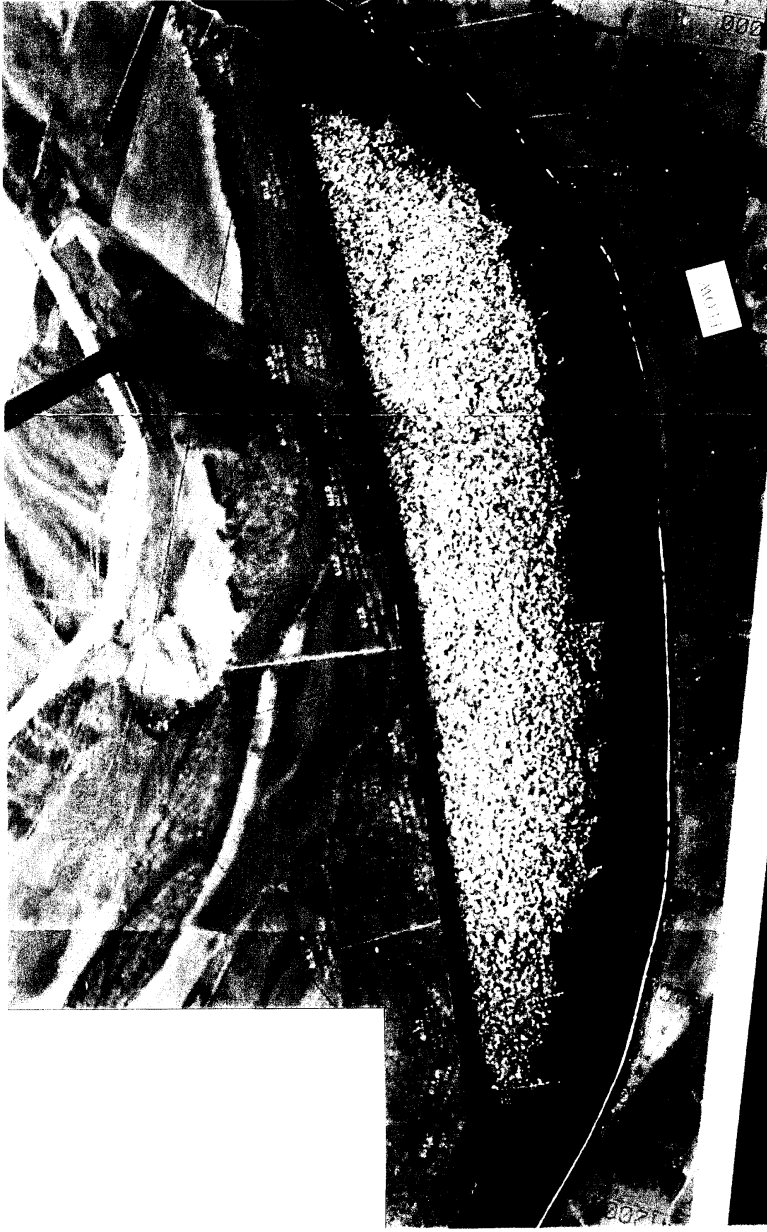
19

Flow visualization showed that flow distribution through the main channel was similar to the base test. Flow still had a tendency to be concentrated at the apex of the bend at Mile 566.0. A greater amount of flow was observed within the dike fields as compared to the base test.

Degrade All Dikes to -2 CRP
